NEW 2ND BRIGADE BASE  
KIRKUK, IRAQ

**SIGIR PA-06-041**  
**APRIL 20, 2006**

SUBJECT: Report on Project Assessment of the New 2<sup>nd</sup> Brigade Base, Kirkuk, Iraq  
(Report Number SIGIR-PA-06-041)

## **New 2nd Brigade Base, Kirkuk, Iraq**

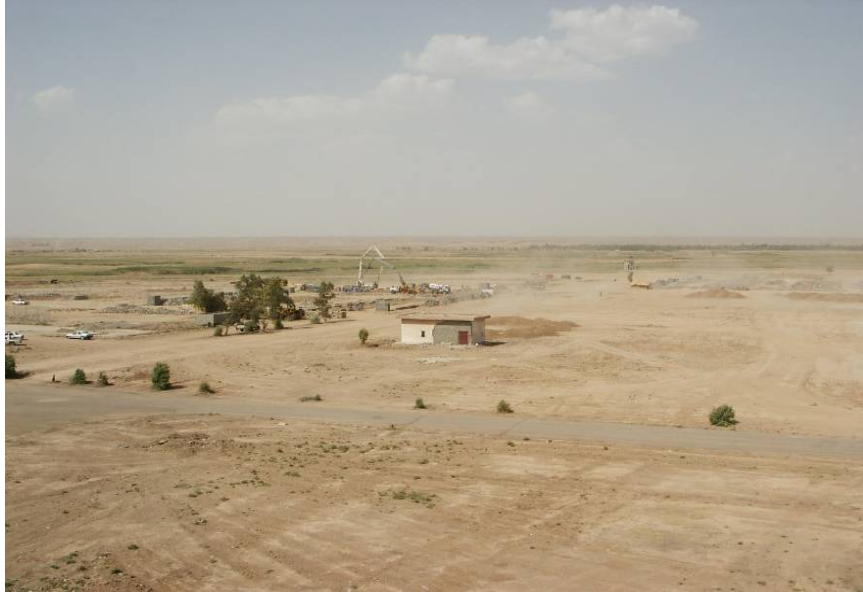
The description of the facility (preconstruction) was based on information obtained from the contractor, AFCEE personnel, and the AFCEE project file. The Kirkuk area Military Base is located within the Tameem Governorate area, approximately 240 kilometers north of Baghdad, Iraq. The project site was approximately ten acres in size and triangular in shape. The site was a former helicopter base, generally level with an existing runway. Utilities for the new site were to be located and connected in coordination with the city of Kirkuk. Since local electricity is not reliable at this time, generators were required to provide primary and backup electricity. The Dibis water treatment plant, renovated under TO 0003, provided water for consumption, life support, and fire suppression, in addition to benefiting the local community. The base water system distributed the water.

**Site Photo 1. Preconstruction location of future 2<sup>nd</sup> Brigade Base**  
(Photo courtesy of ECC)

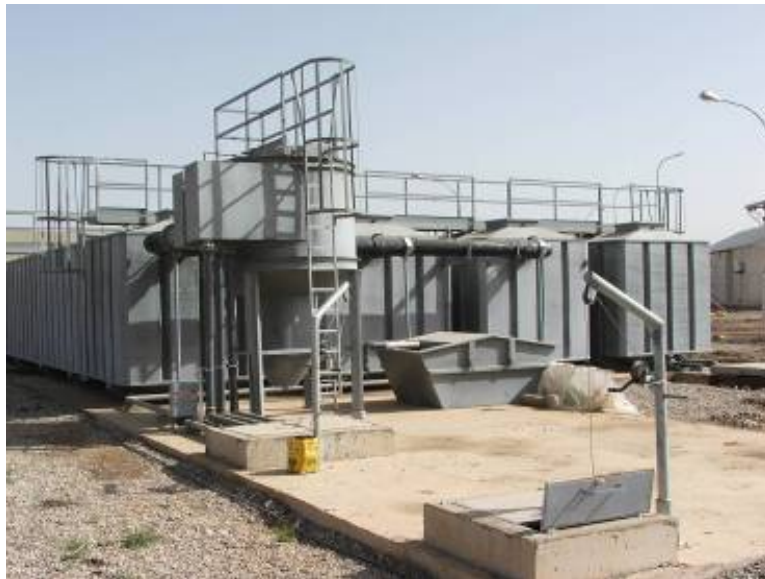
At the time of the assessment, the selection and fabrication of the wastewater treatment system was complete and the system was in-use (Site Photo 2). The treatment system used physical, biological, and chemical processes to purify the water before discharge. Site Photos 3 and 4 show the flow diagram and a filter press for the wastewater treatment plant, respectively. The wastewater treatment plant appeared to meet the contract requirements.

**Site Photo 2. Waste water treatment plant**

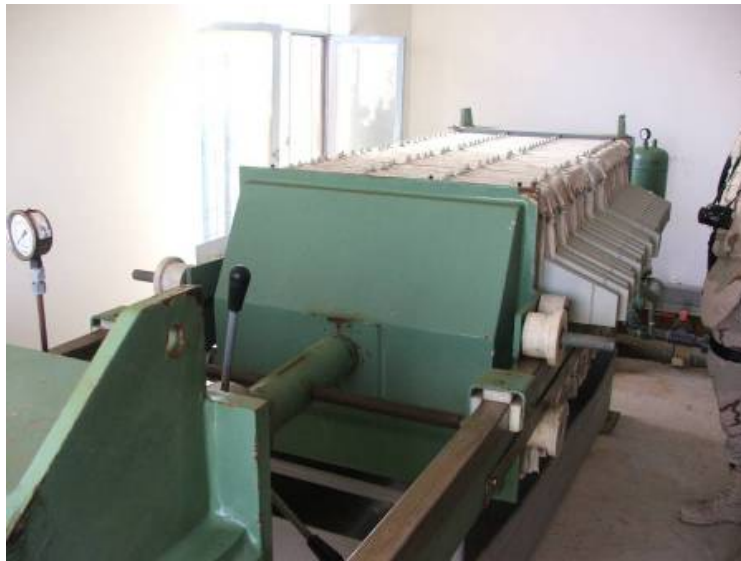
**Site Photo 4. Filter press for waste water treatment plant**

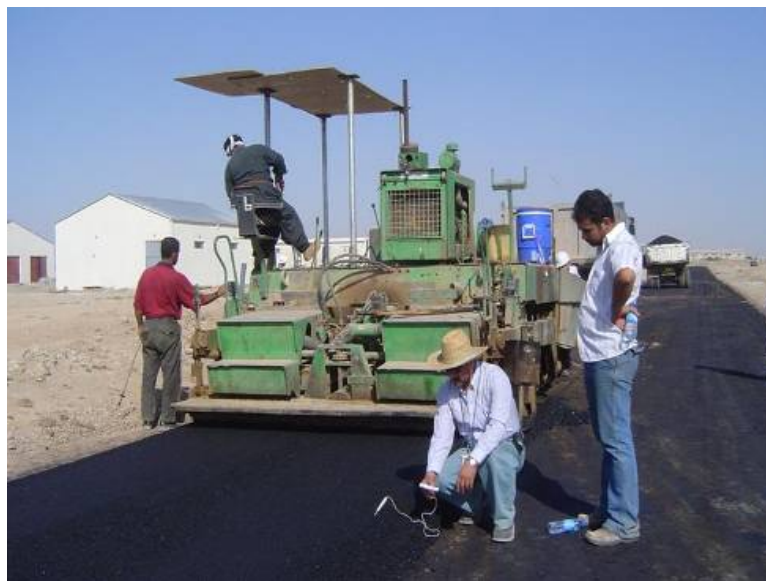
**Site Photo 5. Asphalt road under construction (Photo courtesy of ECC)**

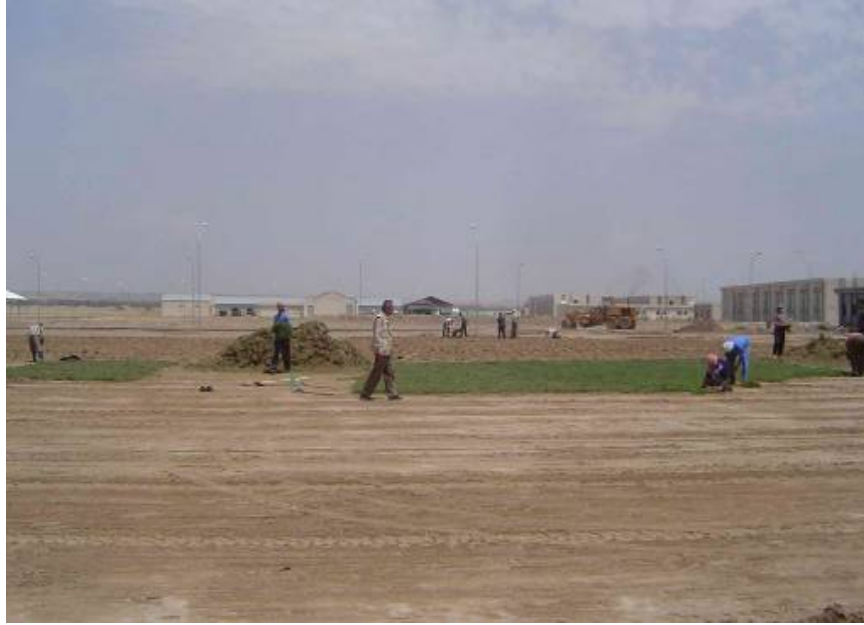
During the site visit, we observed a completed parade ground with reviewing stand and four soccer fields. Site Photo 6 shows the soccer field during construction, while Site Photo 7 shows a soccer field in use by Iraqi soldiers at the time of our assessment.

**Site Photo 6. Soccer field under construction**  
(Photo courtesy of ECC)

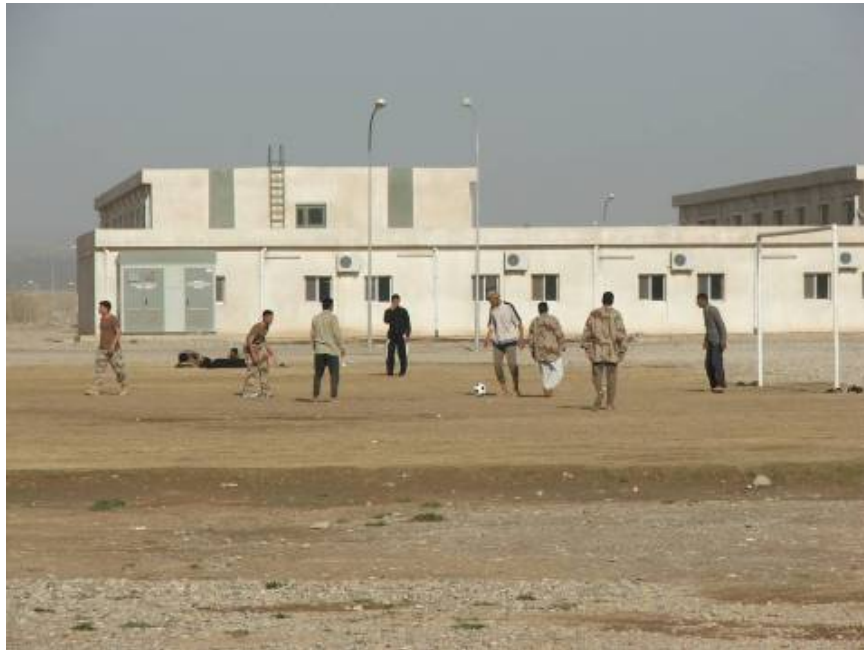
**Site Photo 7. Iraqi soldiers using soccer field**

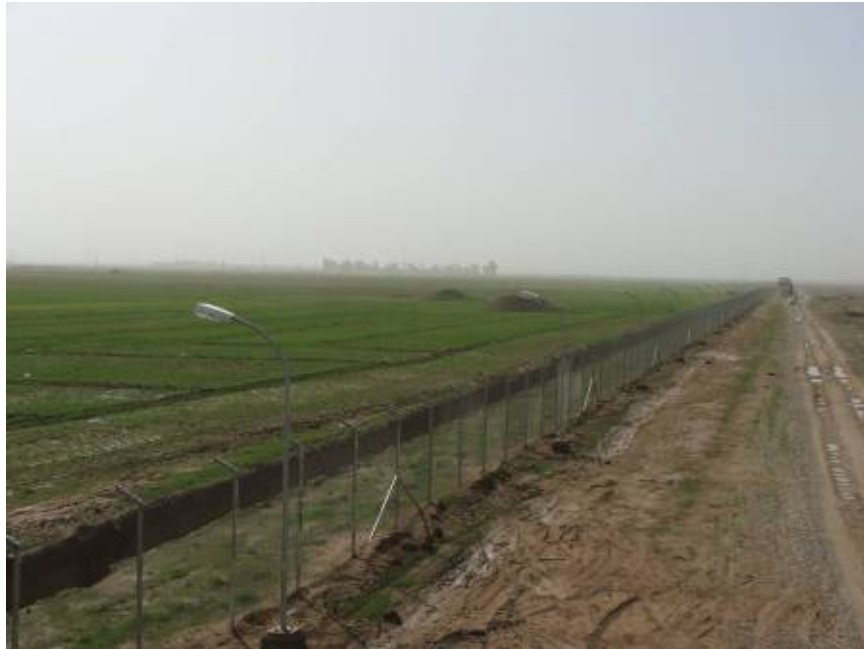
The contract required the construction of a perimeter security fence. The design specifications required a lighted fence around the perimeter of the base with a concrete wall, berms or a trench, and observation posts. We observed a perimeter fence, trench, and observation posts manned with armed guards, as shown in Site Photos 8 and 9, respectively. Concrete walls, berms, and trenches were installed to prevent vehicles from easily driving through the fence. The fence, vehicle obstacles, and manned guard observation post observed during the assessment appeared to meet the design specifications and be practical and functional.

**Site Photo 8. View of fence and trench from observation post**

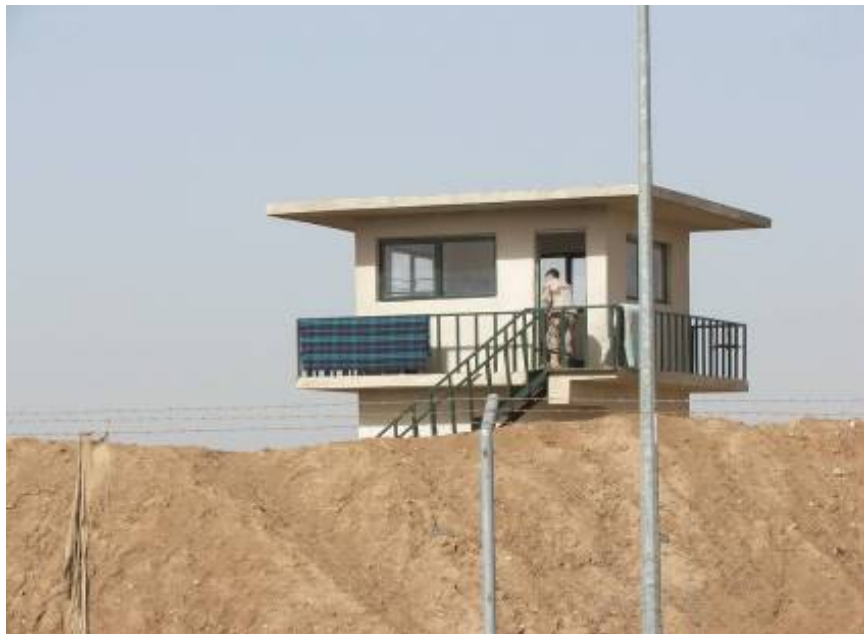
**Site Photo 9. Observation Post**

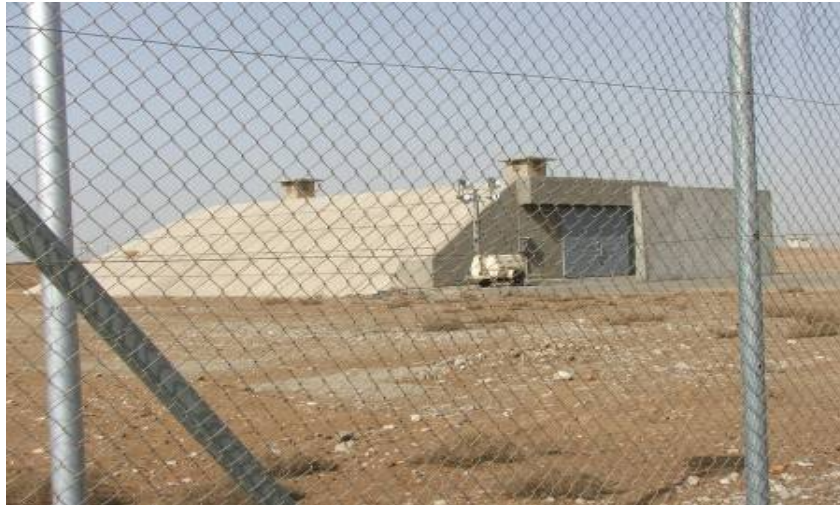
At the time of the assessment, the design and renovation work for the ammunition supply point (ASP) was complete (Site Photo 10). The SORS originally required the new construction of an ASP facility, with the size of the facility 40 meters by 60 meters and 4 meters tall. A subsequent contract modification cancelled the construction of a new ASP facility and required the renovation of an existing building to meet ammunition storage requirements. We were told that the ASP was in use for the intended purpose.

**Site Photo 10. Ammunition supply point**

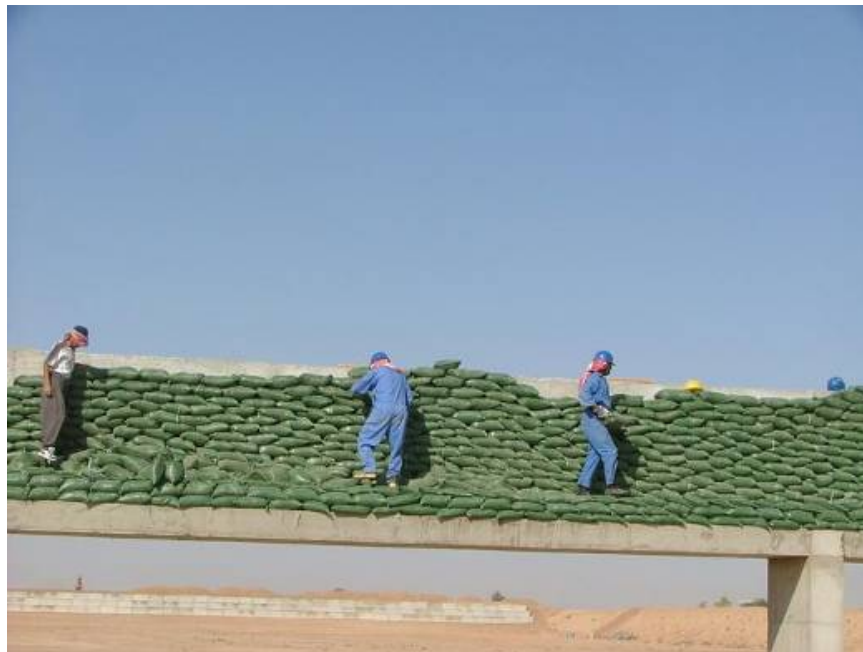
At the time of the site assessment, the design and construction of three small arms ranges was complete. A TO modification required the use of a baffle system designed to minimize ordnance from being fired over the firing range backstop. We observed the small arms ranges constructed with baffles so that projectiles could not go over the backstop berms. Site Photo 11 shows one of the small arms ranges and baffle system. The lower section of the picture is the target area and berm with Iraqi workers installing green sandbags on the concrete baffle.

**Site Photo 11. Small arms range baffle under construction (Photo courtesy of ECC)**

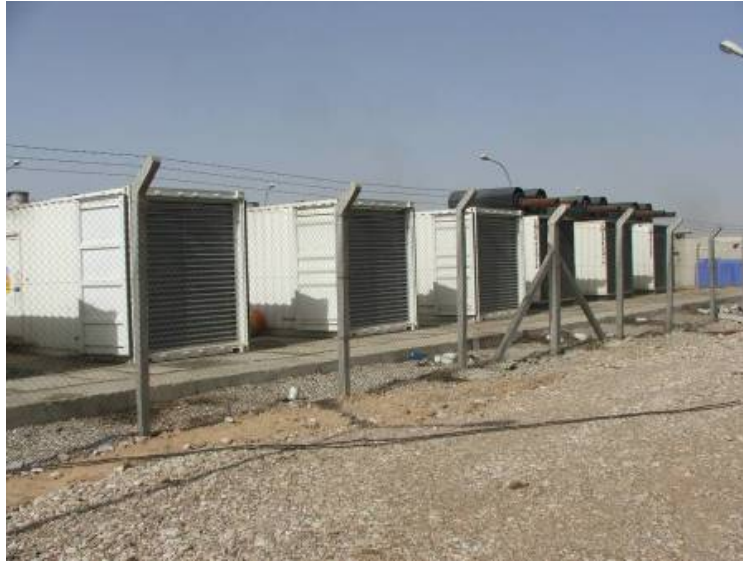
power. A group of eight self-contained 1 MW diesel generators were installed and in-use for their intended purpose of providing electrical power to the base (Site Photo 12).

**Site Photo 12. Eight 1MW electrical generators**

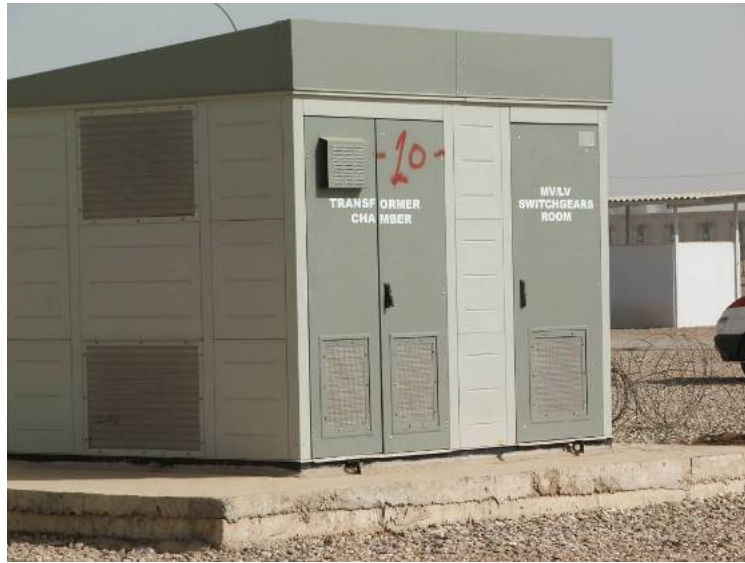
The power distribution system consisted of power transmission lines, including high and low voltage cable, switchgear, transformers (Site Photo 13), concrete pads, security fencing, covered central fueling station with a containment system (Site Photo 14), cooling system, generator building, and generator office. The central fuel supply requirements were to provide double walled tanks with two supply fittings, a concrete pad with a spill retention wall, grounding, and shading. The 24-hour fuel supply appeared to meet the requirements of the contract and was in-use at the time of the assessment.

**Photo 13. Electrical transformers and switchgears**

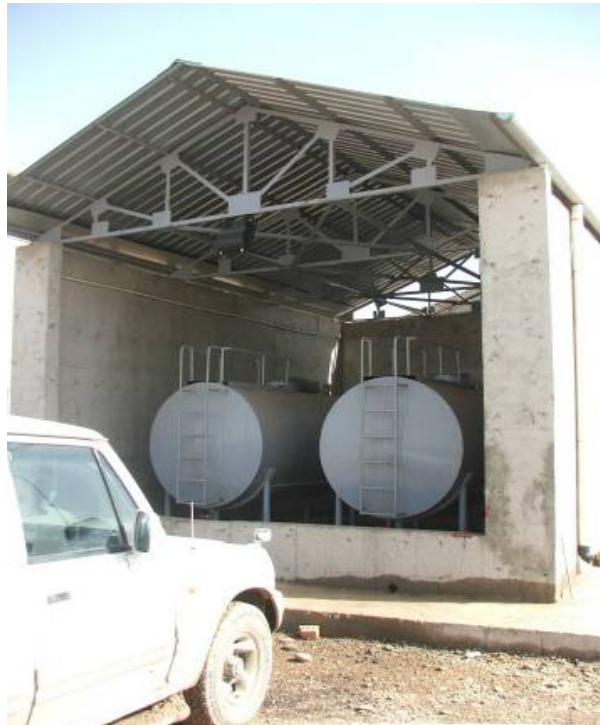
**Photo 14. Central fuel supply**

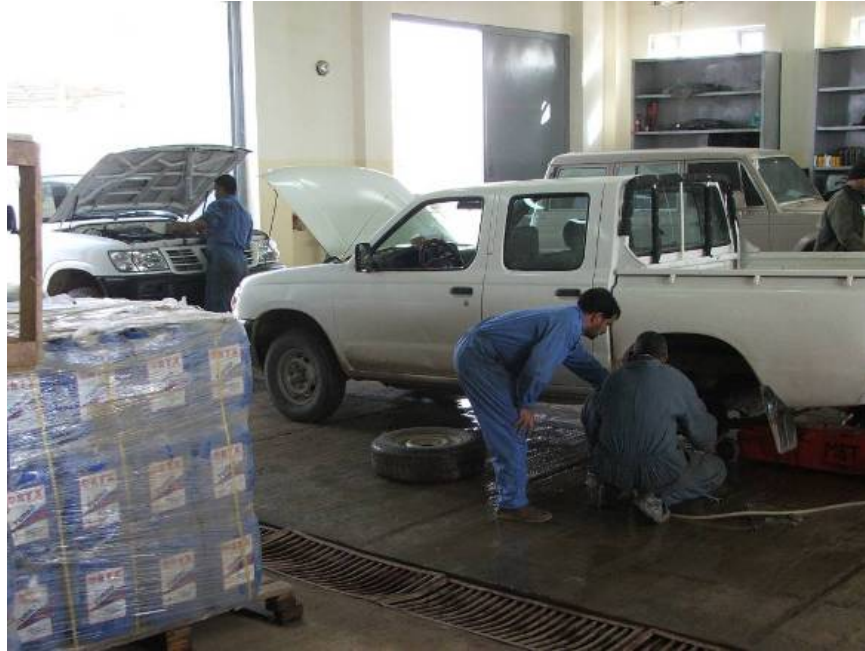
The SORS required the construction of four separate 6-bay maintenance facilities and three maintenance shops with the approximate sizes of 17 meters x 30 meters and 12 meters x 17 meters, respectively. At the time of the assessment, design and construction work was complete on the motor pool. The motor pool appeared fully stocked with equipment and was in-use for the intended purpose during the assessment (Site Photos 15 and 16). The motor pool appeared to meet the contract requirements.

**Site Photo 15. Six bay maintenance facility in use**

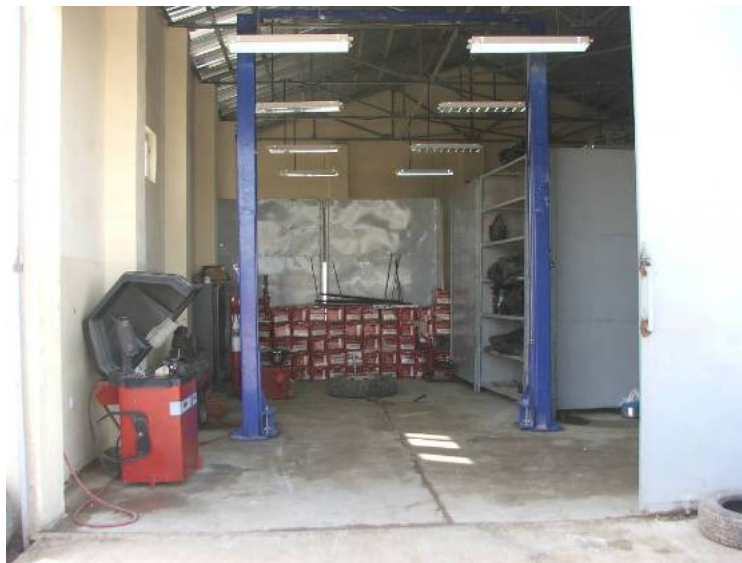
**Site Photo 16. Maintenance shop bay**

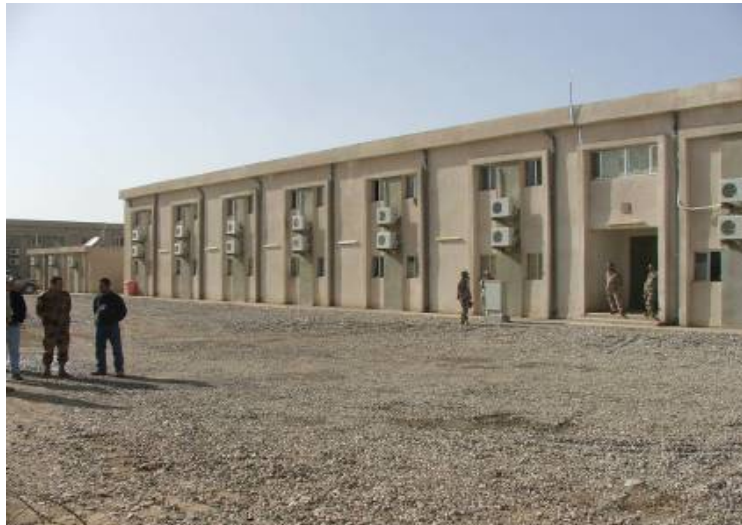
The barracks appeared to meet the requirements of the contract. We observed lighting, fans, electrical outlets, laminated glass windows, fire alarm and air conditioning systems, which appeared to be functional and meet contract requirements. Site Photos 17 and 18 show the outside of the barracks and a bunkroom in the enlisted barracks.

**Site Photo 17. Exterior view of enlisted barracks**

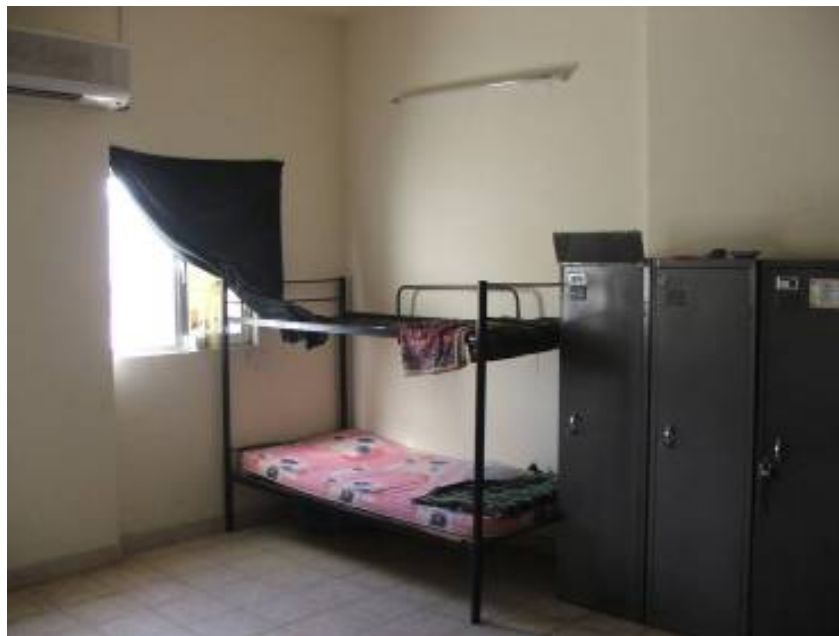
**Site Photo 18. Sleeping quarters of enlisted barracks**

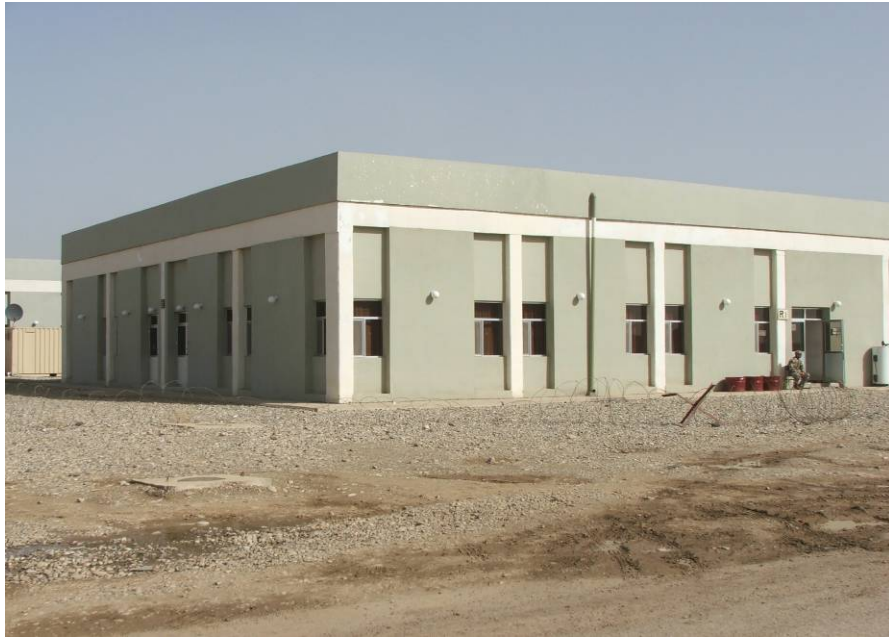
The SORS required the construction of three dining facilities, each in the approximate size of 24 meters x 30 meters and capable of seating 256 soldiers at a time. At the time of the assessment, the design and construction of the dining facilities were complete (Site Photo 19). Site Photos 20 and 21 show the dining facility in-use for lunch and during cleanup, respectively. From the brief site visit and from viewing the photos taken during construction, the dining facilities appear to have met the contract specifications. Due to the customs and preference of the Iraqi cooks, the contractor provided gas burners for the

**Site Photo 19. Outside of dining facility building**

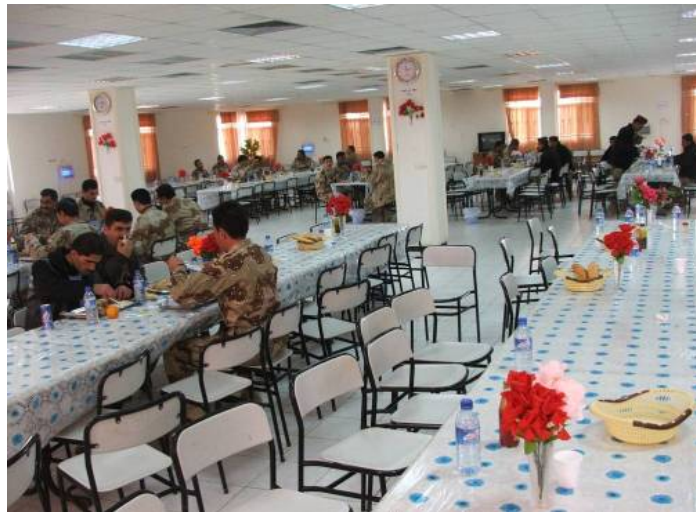
**Site Photo 20. Dining facility in use**

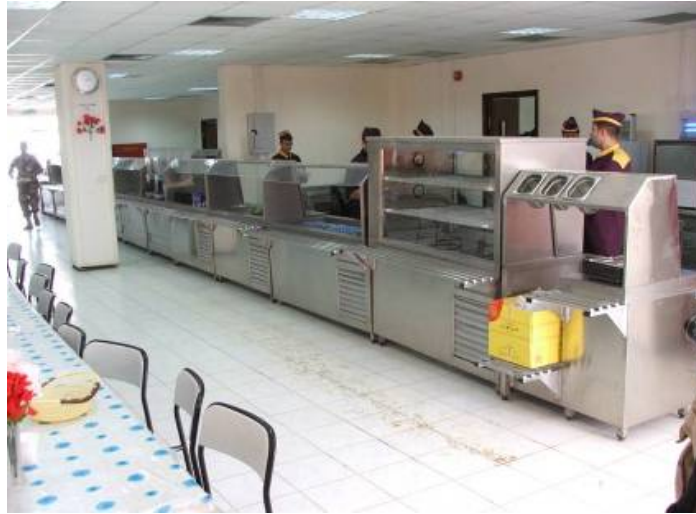
**Site Photo 21. Dining facility food line**

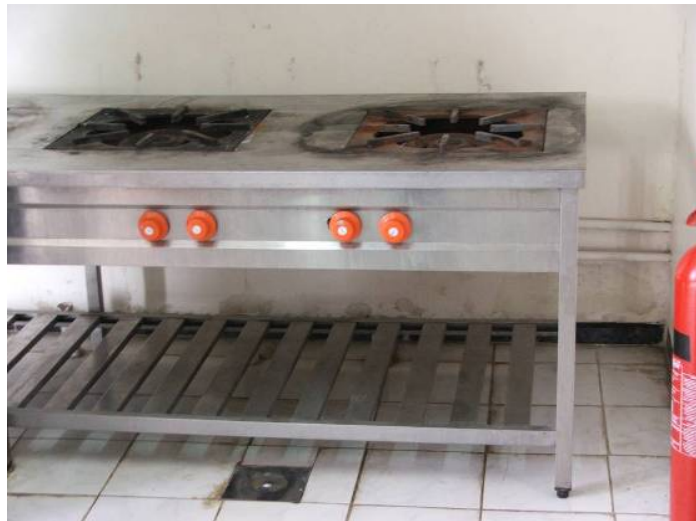
dining facilities, as shown in Site Photo 22. The dining facilities were in use for their intended purpose during the site assessment.

**Site Photo 22. Propane stove in dining facility**

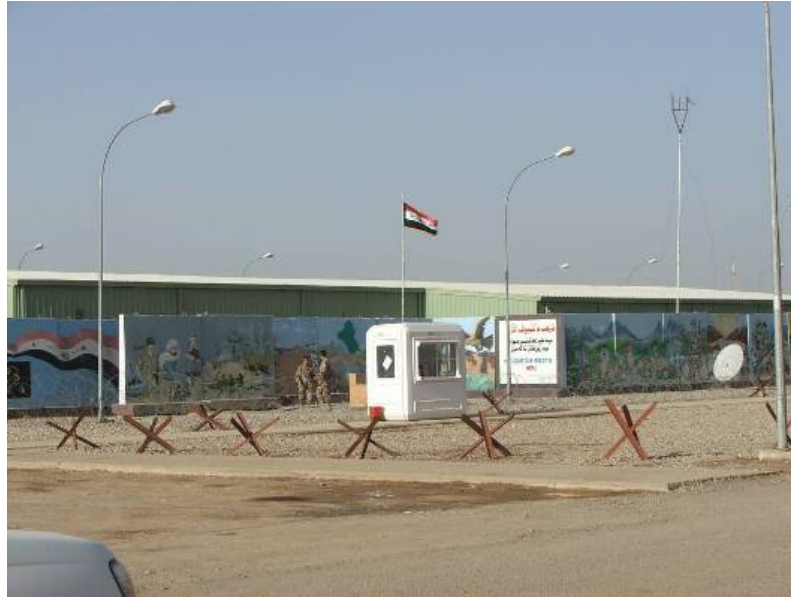
At the time of the assessment, the headquarters building design and construction were complete. The single story headquarters building was behind the concrete walls, as shown in Site Photo 23. Due to the time limitation on site, we did not assess the headquarters building during this visit.

**Photo 23. Headquarters building**

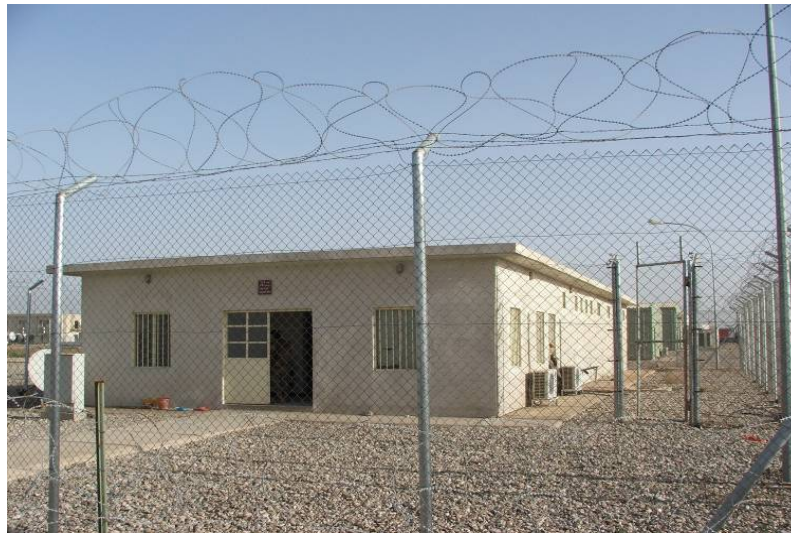
During the assessment, we visually observed the outside of the jail facility (Site Photo 24). The design and the construction of the jail were complete. The jail was in-use at the time of the assessment and therefore the assessment team did not have the opportunity to examine the inside or outside of the facility close-up. Instead, the assessment team reviewed the contractor's during and after construction photographs to determine whether the jail met the intent of the contract's requirements. It appears the jail did meet the specifications of the design.

**Site Photo 24. Jail facility**

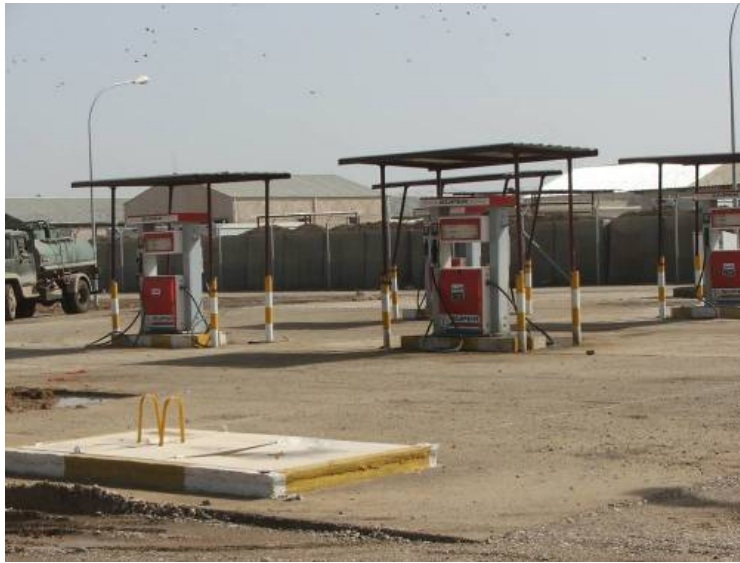
At the time of the assessment, the design and construction of the gasoline station were complete (Site Photo 25). The design was changed to consolidate all gasoline stations into this one station for better management and control. The station appeared to be level with good drainage of the concrete pad. The facility had a small office, four covered

gasoline pumps, and two underground tanks. The gasoline station appeared to meet the specifications of the design and to be well constructed.

**Site Photo 25. Gasoline station**

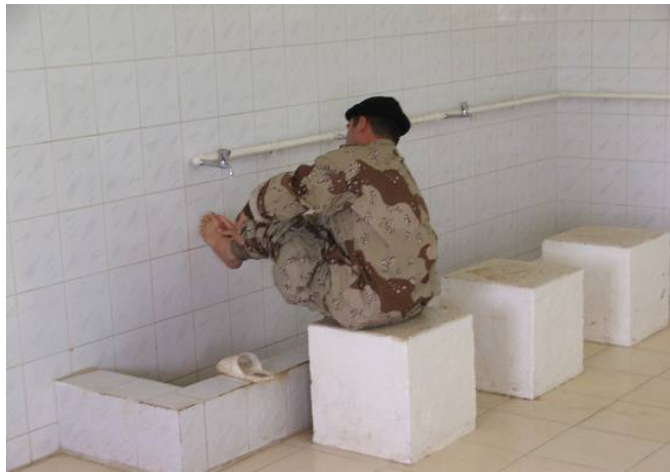
**Site Photo 27. Restroom next to the mosque**

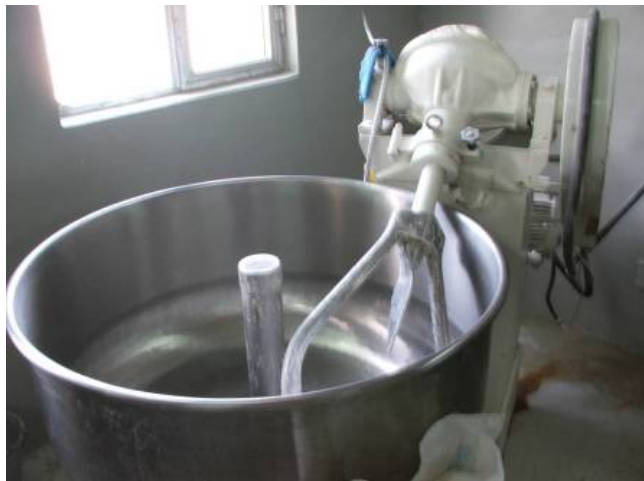
In order to provide the Iraqi Army soldiers with fresh bread, a bakery was designed and constructed. The contractor furnished the bakery with industrial sized equipment, such as a mixer (Site Photo 28) and oven (Site Photo 29).

**Site Photo 28. Mixer used in bakery**

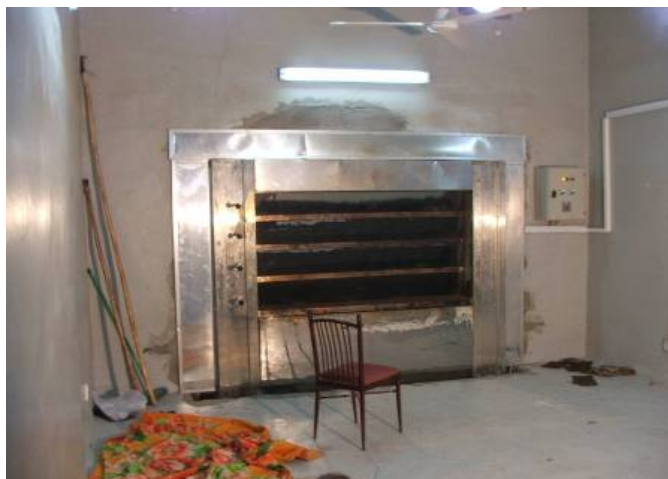
**Site Photo 29. Oven in bakery**

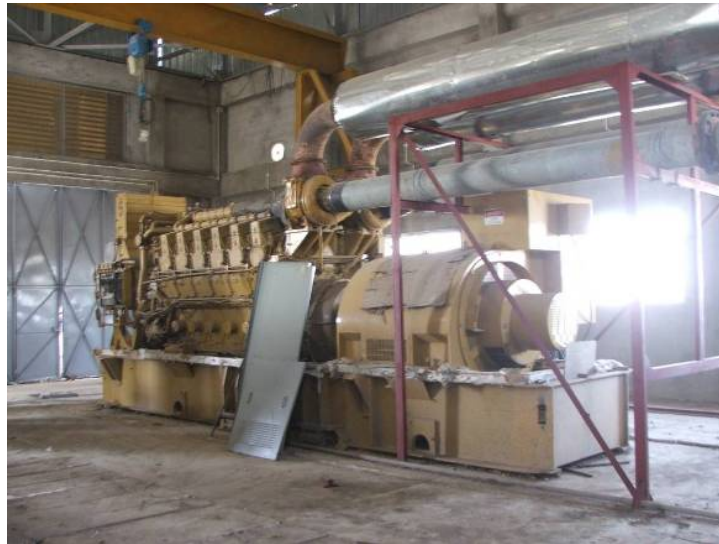
Work was pending on the installation and commissioning of the second bank of generators for the primary power distribution system. The two remaining primary power generators were government furnished equipment that was surplus from another site outside of Iraq. Each of the diesel generators was rated to produce 2.5 MW of electricity. The generators had been installed on a new concrete pad with a new generator building constructed around them. The contractor was in the process of connecting and commissioning the generators. Synchronization and load sharing of the power generation system was required to complete the contract. Site Photo 30 shows one of the generators inside the new generator building. We observed the installation of supporting equipment for the power generation system, such as the fuel supply and the cooling system (Site Photo 31), which appeared to meet the contract requirements.

**Site Photo 30. 2.5 MW Electrical generator provided as government furnished equipment**

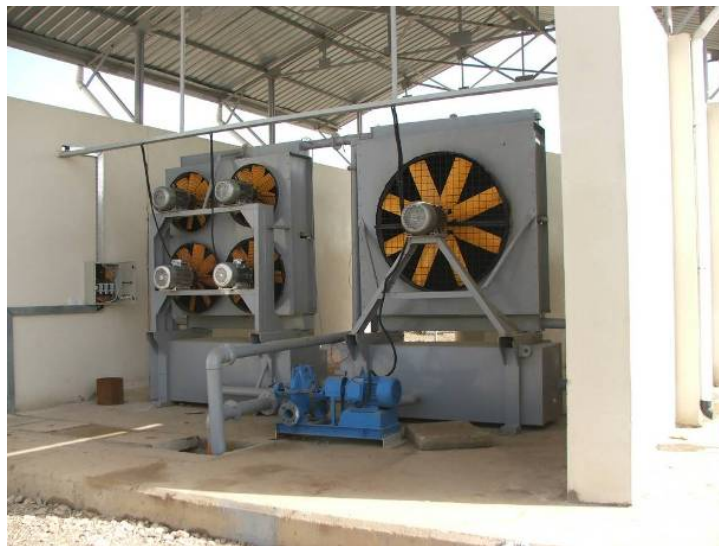
**Site Photo 31. Generator building cooling system**

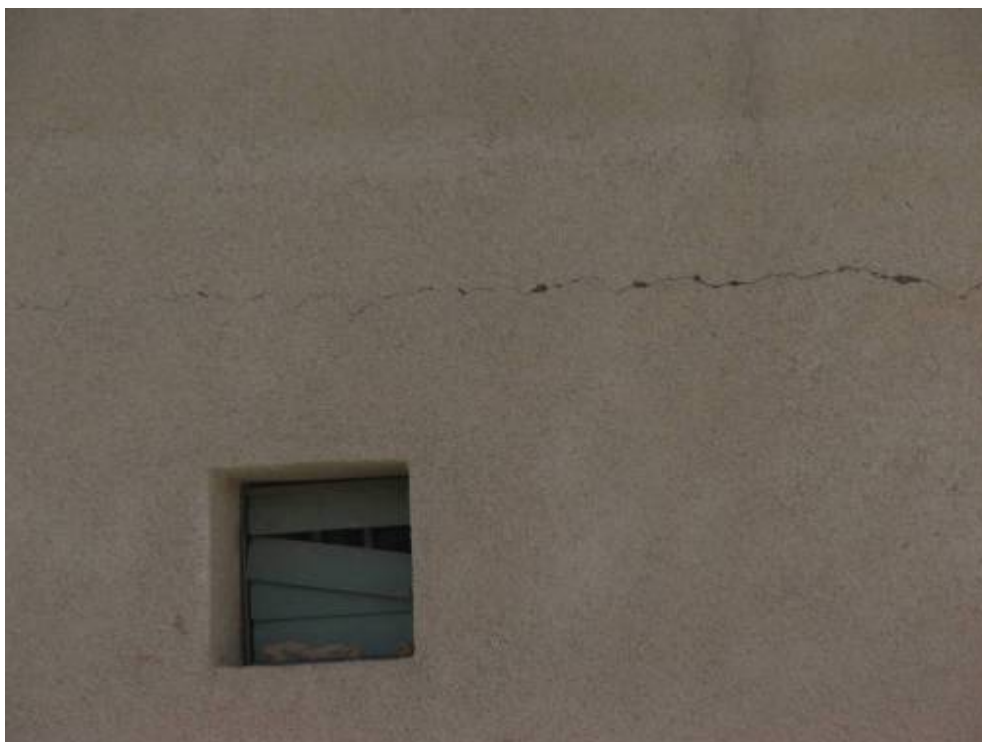
We observed warranty items, such as cracks in the exterior stucco walls (Site Photo 32), which need repair.

**Site Photo 32. Crack in exterior stucco wall**

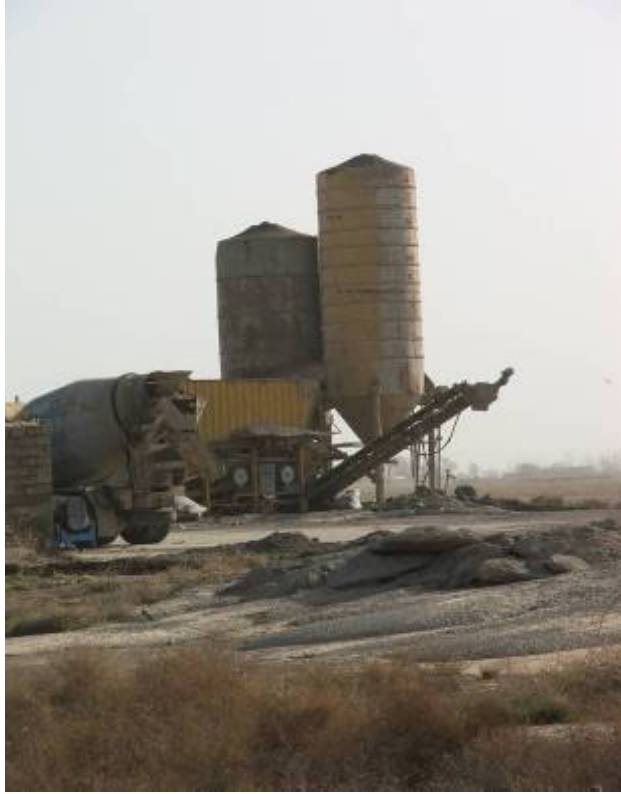
During construction, as many as four concrete batch plants were on site mixing concrete (Site Photo 33). The use of the concrete batch plants, an on-site laboratory, and field QC testing (Site Photo 34) all appear to have contributed to more consistent concrete quality.

**Site Photo 33. One of the remaining on-site concrete batch plants**

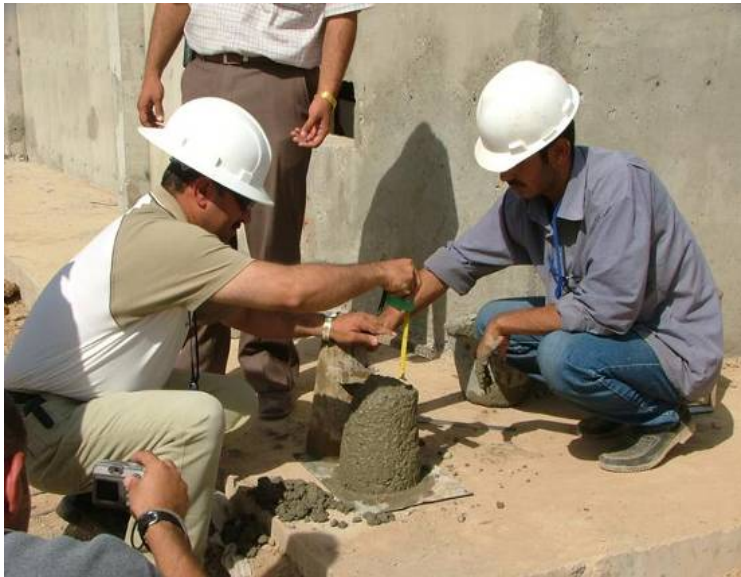
**Site Photo 34. Field QC testing during construction (Photo courtesy of ECC)**
